**Finite Element Analysis of Wood Shoring Towers used in
Urban Search and Rescue**

Thesis

The University of Texas at Austin

December 2012

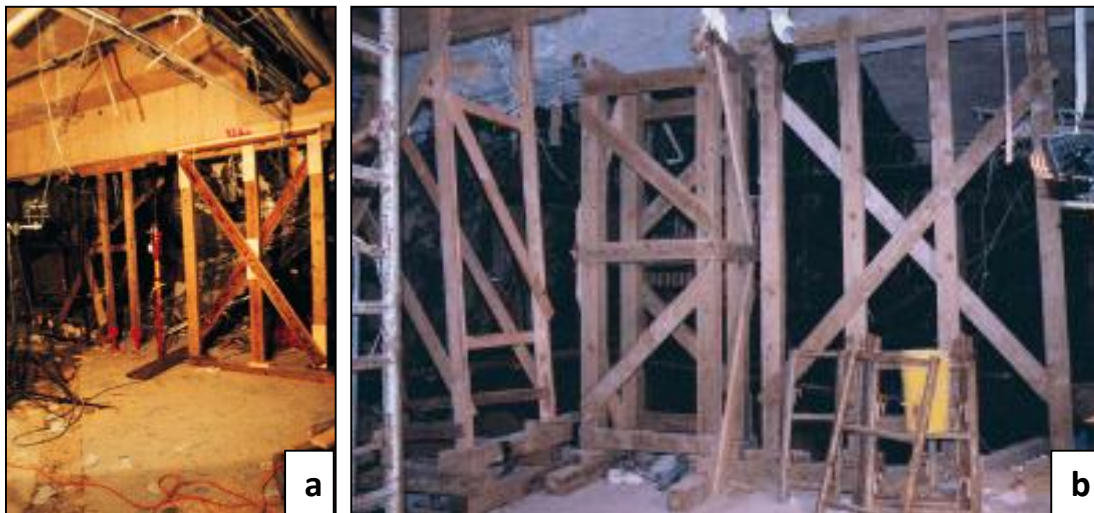
Figure 2.6 Shoring at the Murrah Building in OKC (a) Vertical shore supporting a fractured floor beam (b) Laced post shore with other vertical shores [Source: O’Connell 18]

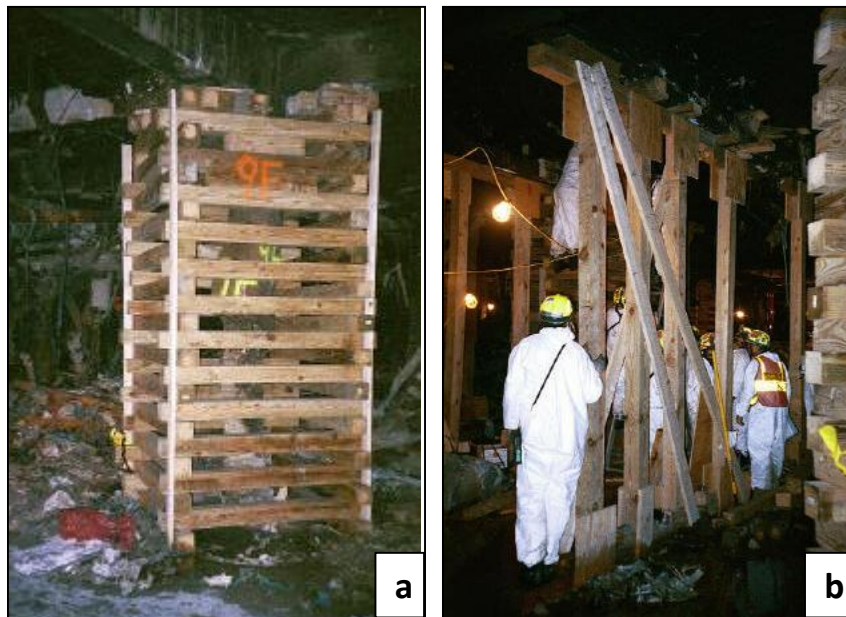
Figure 2.7 Shoring at the Pentagon in Washington D.C. (a) Crib shore (b) Vertical shores constructed near crib shore [Source: Titus 22]

Upon rigorous inspection and evaluation by structures specialists, it was determined that the structure was unstable and that several crib shores and vertical post shores were needed to support the damaged parts of the structure. As in the case with Oklahoma City, vertical post systems constructed at the Pentagon served to support beams, floor slabs, and overhead debris. They were located strategically in various areas to provide protection to the shoring squads so they could safely access more critical areas that needed the higher capacity crib shores (22). Photos of typical vertical shores in place at the Pentagon are shown in Figure 2.7.

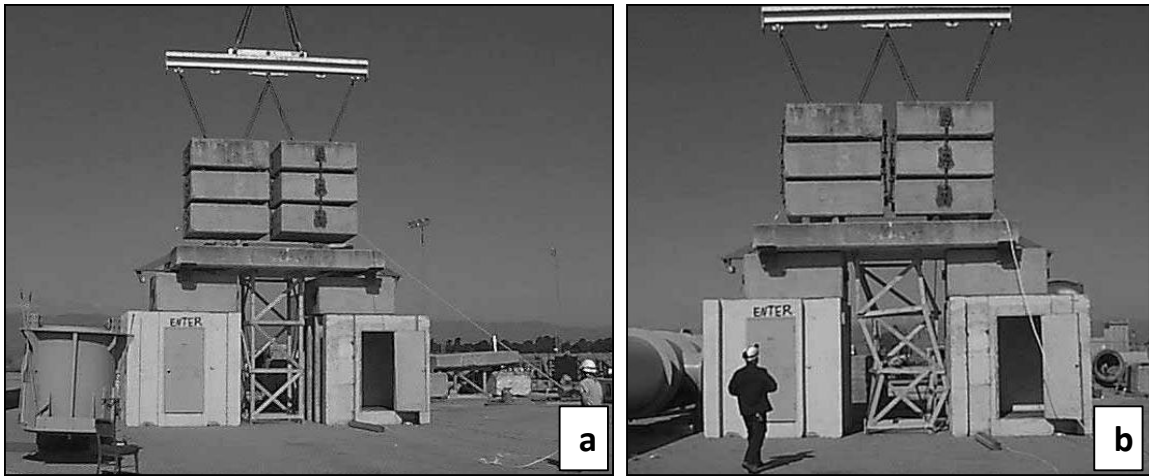
Figure 2.8 (a) Loading of LP shore using crane (b) Failure of LP shore after addition of third pair of concrete blocks [Source: Hammond 6]

A total of three series of tests were run between May 2001 and March 2005 on 12.5 feet high laced post (LP) specimens. The testing apparatus consisted of a 150 ton bridge crane that was used to lower a 38 kip concrete slab on top of the shores. Next, additional weight, in the form of 12.5 kip pairs of concrete blocks, was added in increments of 25 kips until failure occurred. For every test, failure of the shores occurred during the addition of the third pair of concrete blocks. In turn, the maximum vertical load capacity could only be estimated to lie within the range of 88 kips to 113 kips. Figure 2.8 presents photos of the overall test setup before and after failure of a LP shore.

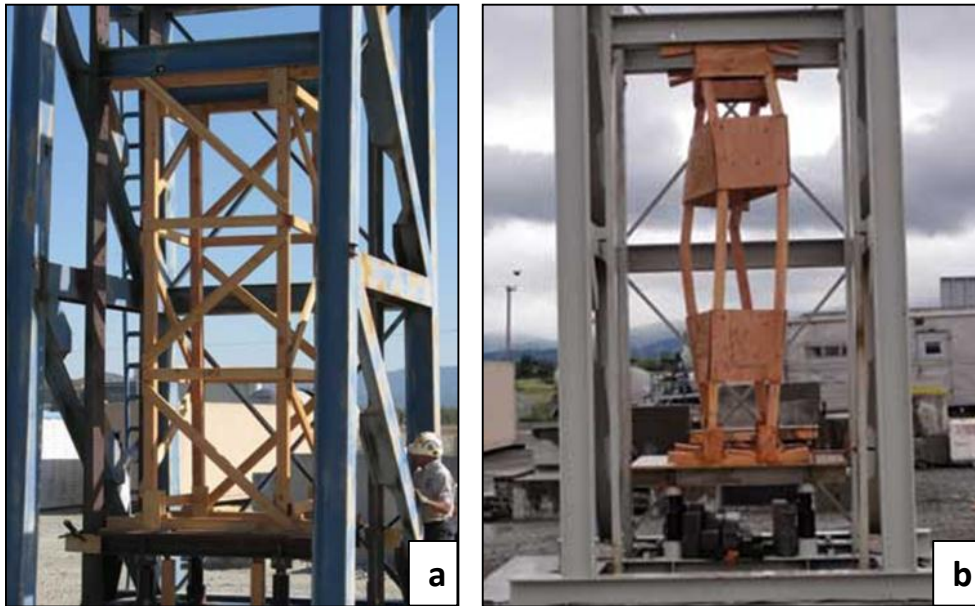
Figure 2.12 (a) Test setup (b) Failure of LP shore [Source: Hammond 6]

Most recently, four series of tests were conducted between May 2007 and May 2010 on 12 foot tall LP and PLP specimens. This time, as shown in Figure 2.12, load was applied by having the four 50-ton hydraulic rams slowly lift the floor of the testing apparatus, causing the top of the shore to press against the steel beams above them. This arrangement allowed the load supported by the shores at any point during the tests to be determined by measuring the pressure in the rams. However, since there was no load averaging manifold in these series of tests, there was no way to verify whether or not each post shared an equal amount of load.

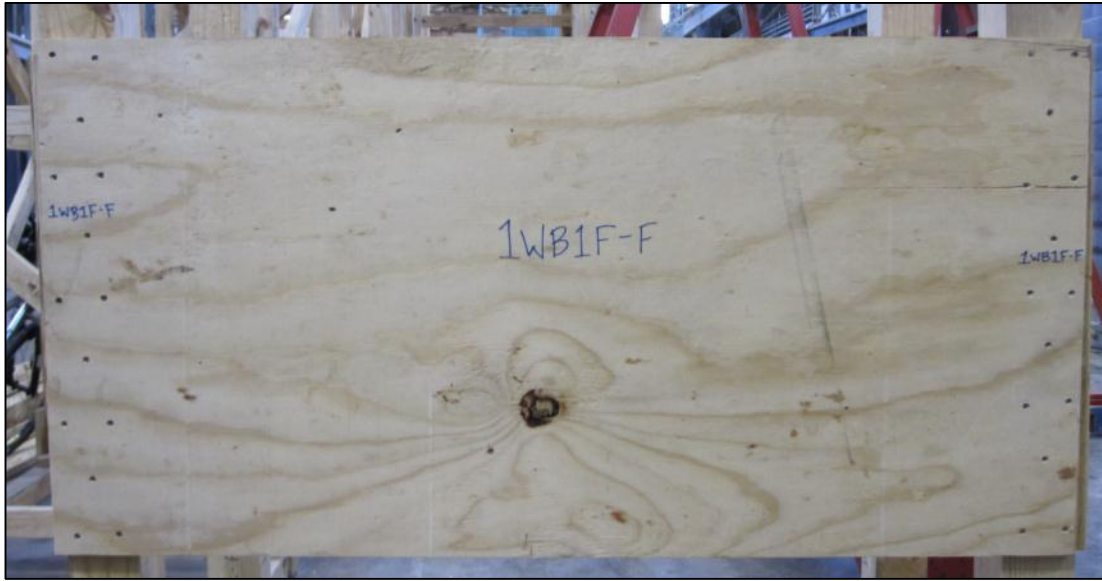
Figure 3.10 Example of shore member label: Shore 1, Wide Brace, Level 1, Front of shore, Front side of member

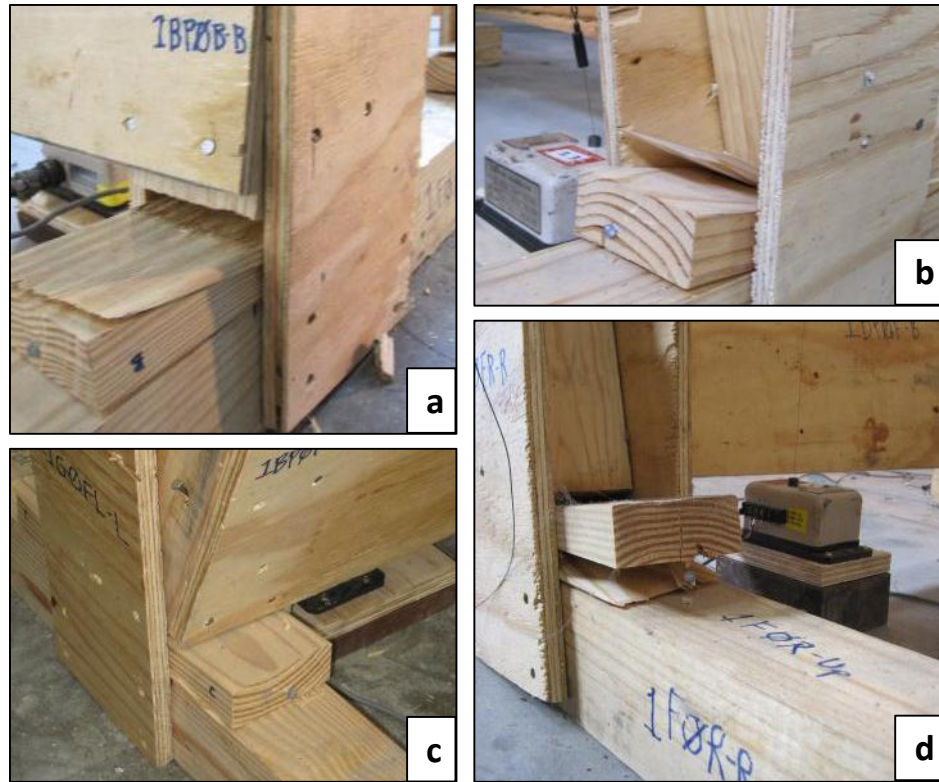
Figure 4.2 Performance of wedges in Test 1 (a) Back-left (b) Back-right (c) Front-left (d) Front-right

At relatively low vertical load levels (20-30 kips), slight cracking sounds in the wood were observed periodically. As the shore neared its vertical capacity (70 kips and above), these noises increased in frequency and intensity. During loading, audible sounds of the wood creaking and cracking were heard from periods of low loads (20-30 kips) up to failure. Cupping of some of the shore wedges also occurred throughout the test. Figure 4.2 depicts these wedge deformations for PLP Shore 1 at the end of testing.

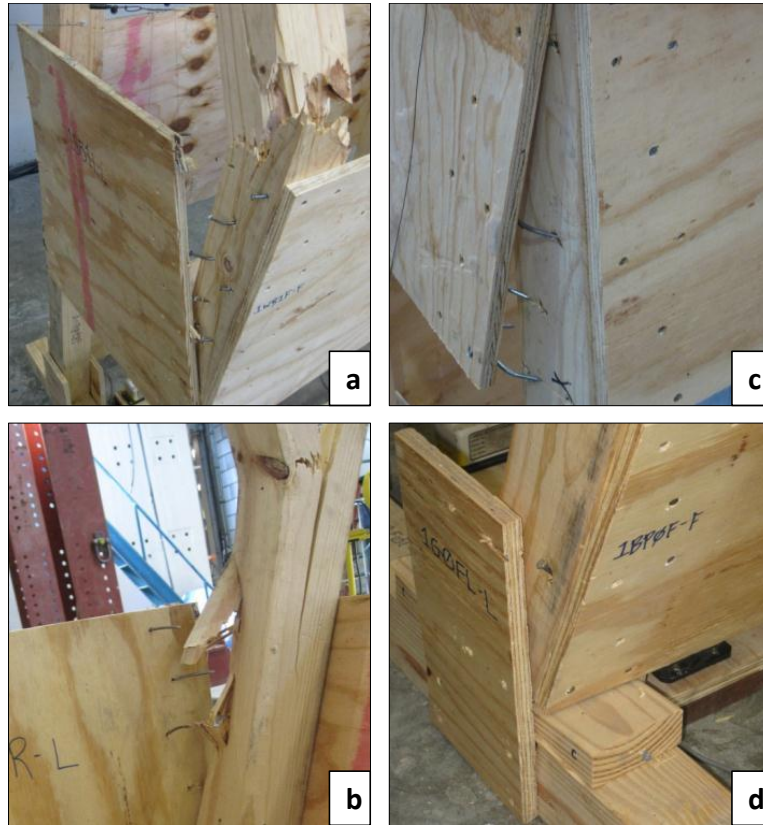
Figure 4.7 Joint failures (a) Pull-through (b) Withdrawal (c) Post splintering (d) Half-gusset rotation and withdrawal

withdrawal became visibly evident as the vertical load neared its peak (70 kips and beyond). This behavior most likely contributed to the decrease in stiffness observed in the load-displacement plot of Figure 4.3. In some cases, the nails pulled cleanly out of the posts but remained attached to the plywood braces, and in others the nails pulled completely through the plywood members while staying attached to the posts. The bent shapes of the nails that exhibited withdrawal were directly related to the direction in which the posts bowed or the plywood brace restrained movement. Some of the nails in the half-gusset plates at the bottom of the shore also pulled through as the posts failed and rotated about the wedges below them. Figure 4.7 illustrates the various types of connection failures in Shore 1.

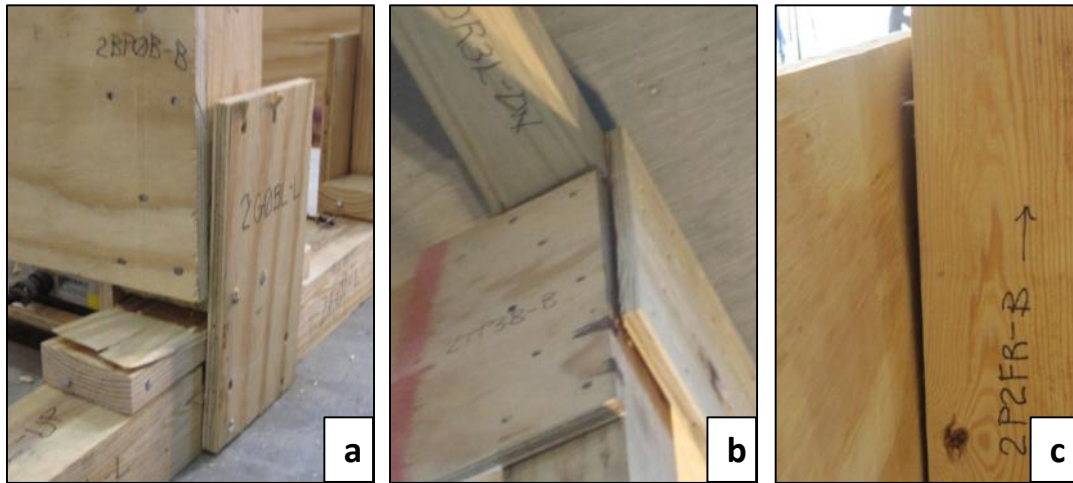
Figure 4.12 *Partial nail withdrawal from Test 2 (a) Back-left at sole (b) Back-left at header (c) Front-right at wide brace*

As expected again, all the failures in the posts occurred within the large unbraced length of the shore. However, in contrast to Specimen 1, the failure mechanisms of Specimen 2 did not involve full nail withdrawal of any joints. Apparently, the wood fibers in the posts of Shore 2 were not strong enough to allow significant stresses to be transferred to the plywood braces and cause nail withdrawal. The only evidence of nail withdrawal that occurred in this test came in the form of partial withdrawal of some of the 8d nails in the half-gusset plates and plywood braces (Figure 4.12).

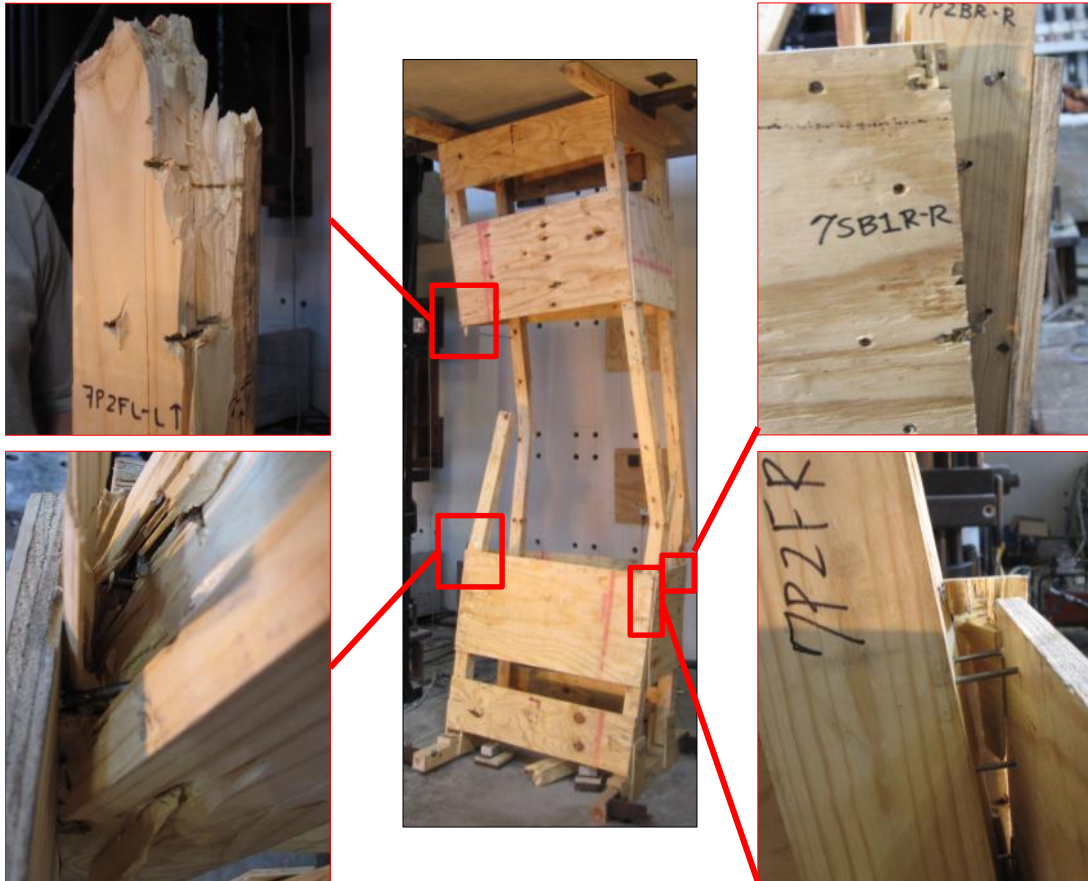
Figure 4.35 Notable regions of joint failure for Test 7
